Manual for lake-irrigation

for the SEABASED-project

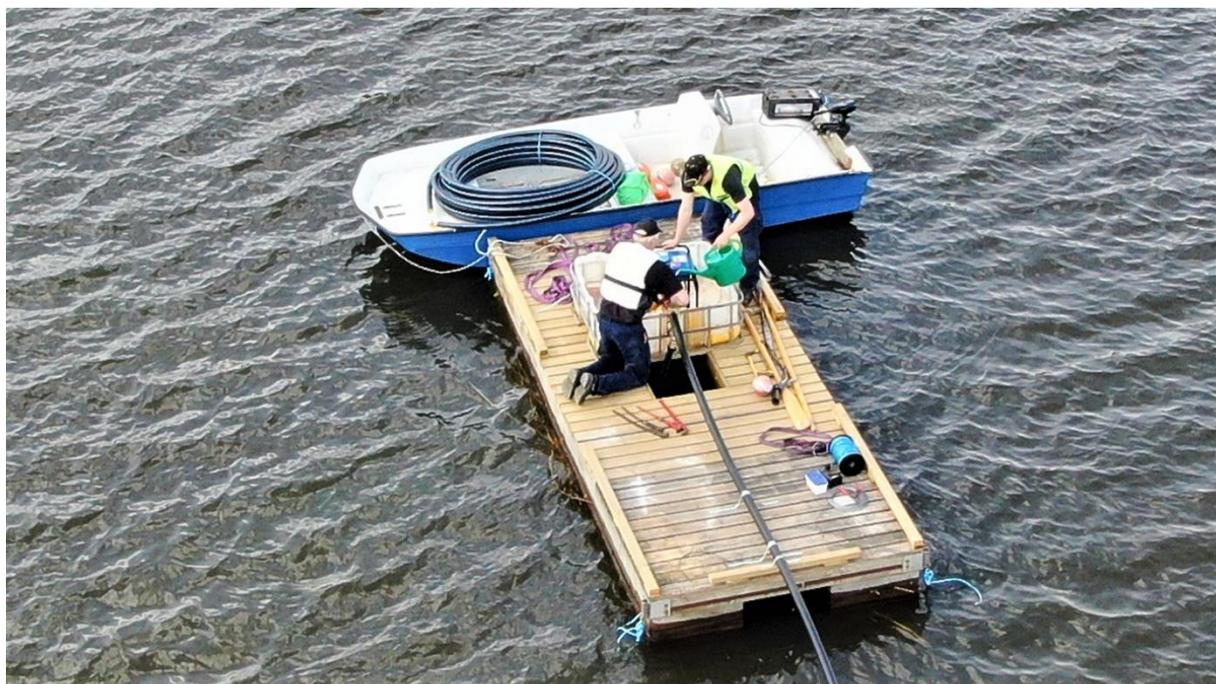
Figure 3. Installation of the irrigation pump at the raft.

In order to be able to carry out the project, 2 irrigation facilities were required because a relocation of the irrigation pump will be unwieldy and it was important to carry out the irrigation at the same time in the two pilot sites, to make sure that the weather did not affect the test result. We judged that we would not be able to have a suction line all the way out into the lake, therefore we placed a raft over the deep area in the lake (Figure 3). On the raft we put a diesel-powered high-pressure pump with a 50mm suction line and bottom strainer about 12 meters deep. As a pressure line, we had a 63 mm irrigation hose to prevent pressure drops (Figure 4). It was branched into a nozzle where 3-5 spreaders could be connected, and water samples could be taken. We used 3 spreaders and then got out the equivalent of about 40mm of rain in 3 hours according to the table, we checked with a rain gauge (Figure 5).

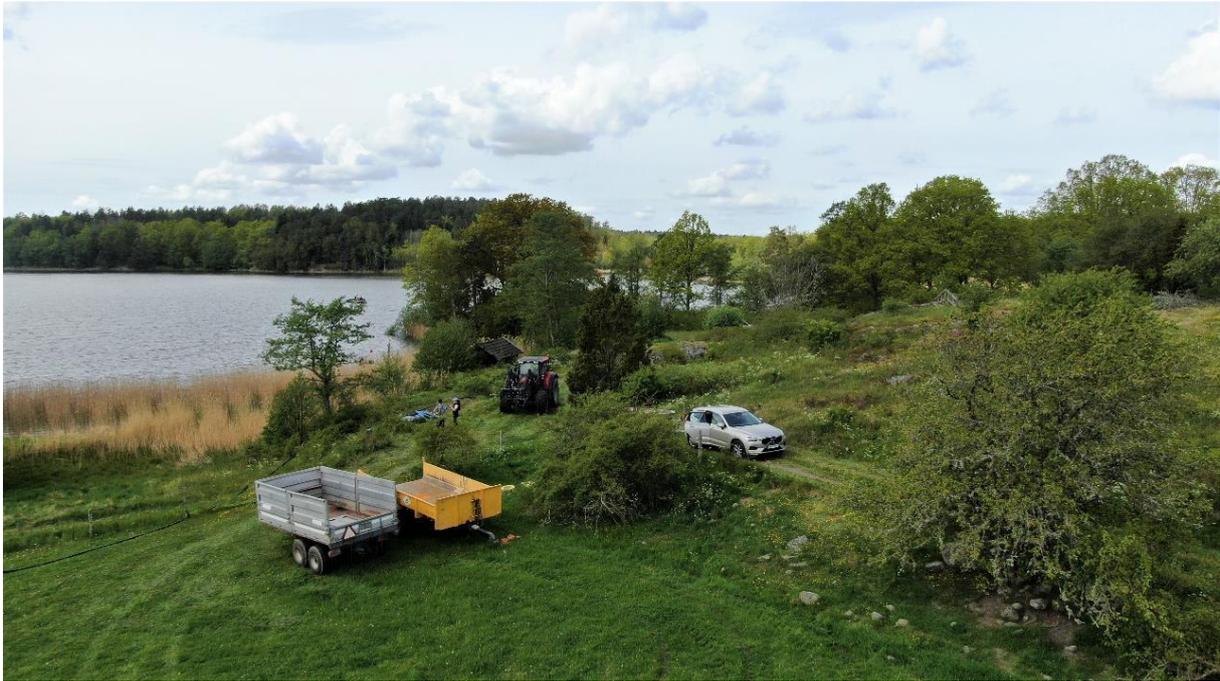
Figure 4. Installation of hoses and equipment.

The same pumping equipment is used for the surface water, but there a 50mm pressure hose was enough because it is so much shorter, about 50 meters.

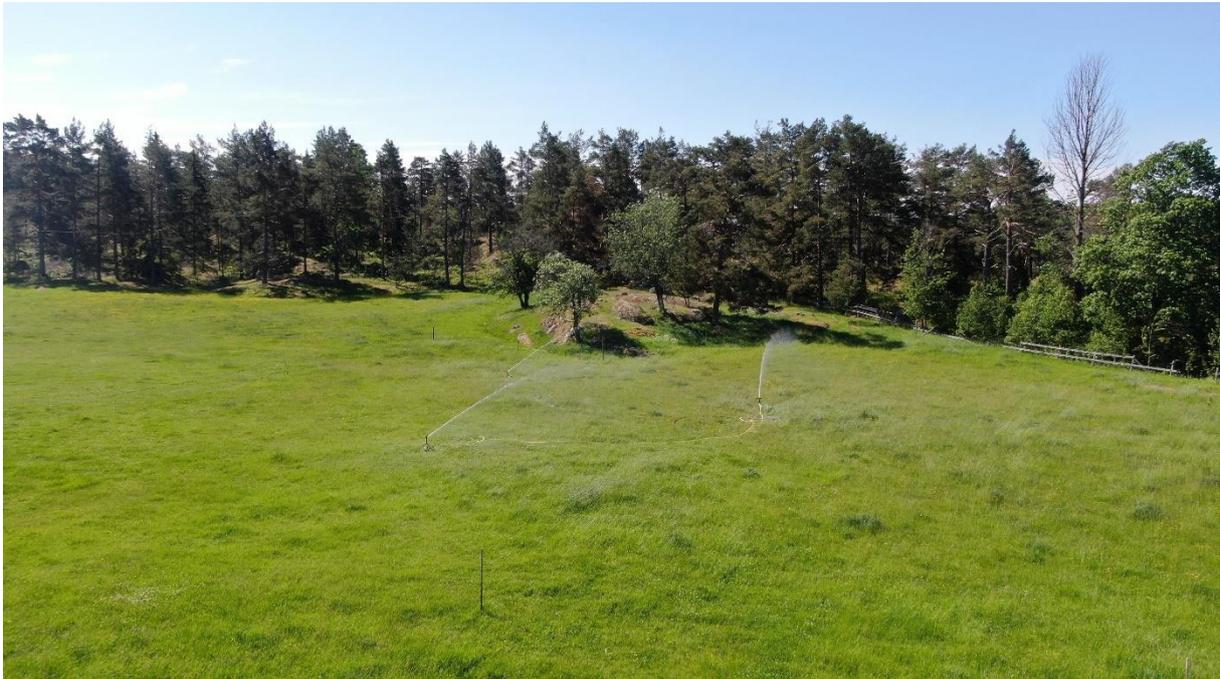
Figure 5. Three spreaders gave about 40mm of rain in 3 hours.
